NASA/TM-2016-219168

Experimental Photogrammetric Techniques Used on Five Full-Scale Aircraft Crash Tests

Justin D. Littell
Langley Research Center, Hampton, Virginia

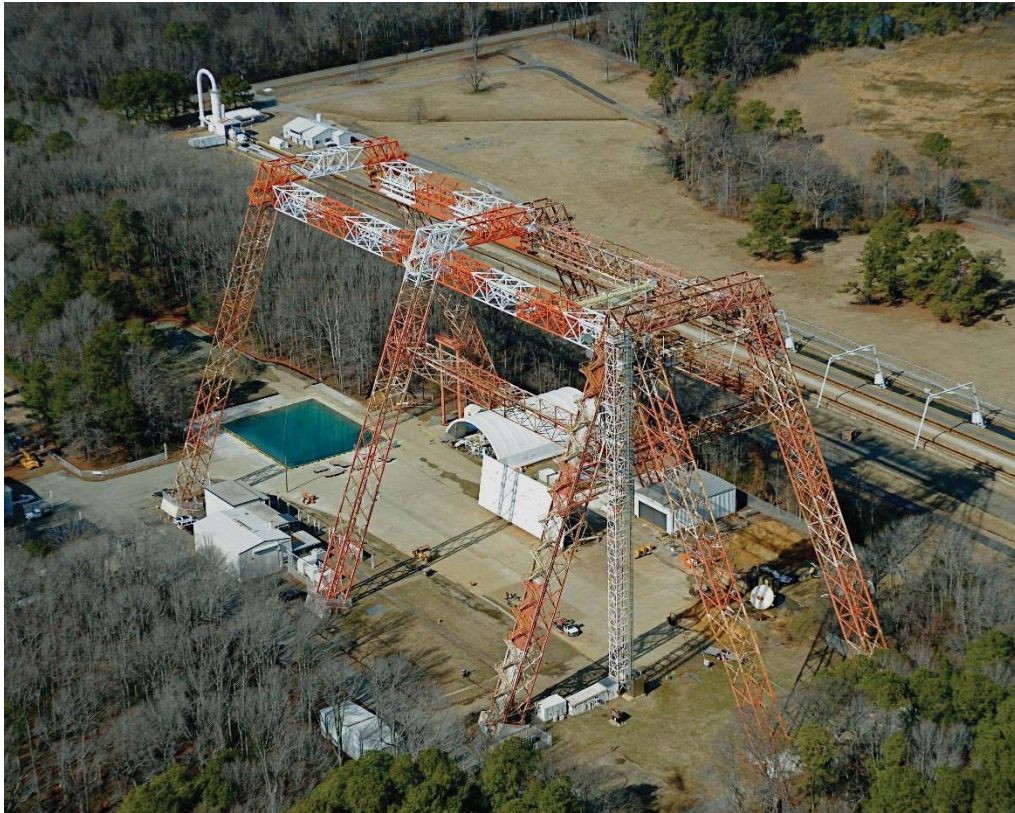
Figure 1 - LandIR facility

NASA Langley Research Center's (LaRC) Landing and Impact Research Facility (LandIR) has a long and rich history of full-scale aircraft crash testing. The facility, originally built in 1965 to train the Apollo astronauts for the moon landings, was converted into a full-scale crash test facility in 1972. It is a 240-ft. high, 400-ft. long steel A-frame gantry structure which uses a cabling system to pendulum swing test articles achieving various combinations of free flight and crash velocities [1]. Full-scale aircraft crash testing has been ongoing for 40+ years, with test articles ranging from small general aviation (GA) airplanes to large military transport helicopters. A partial history of testing up through the late 1990's is summarized in [2], with more recent tests summarized in references 3 through 7. Figure 1 shows the LandIR facility.

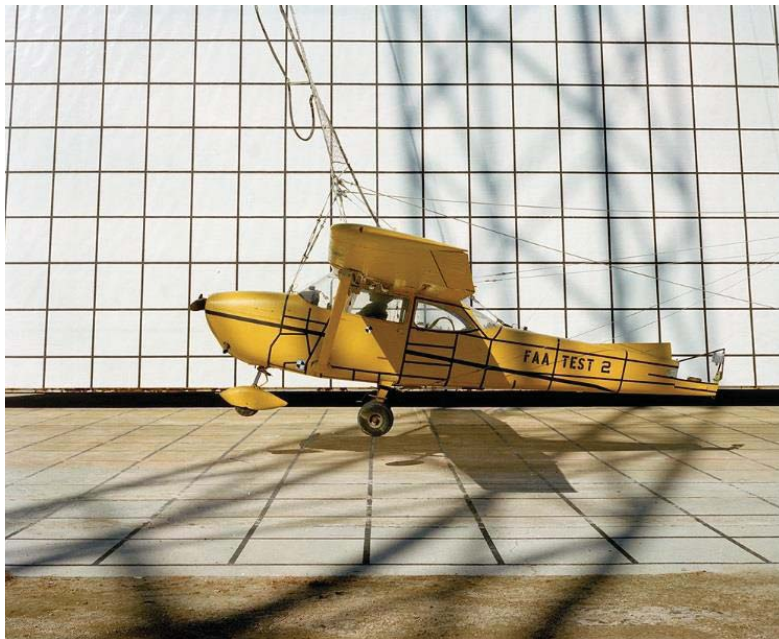
Figure 2 - Historical painted patterns for use in tracking

In order to obtain useful data from the crash tests, points of interest need to be identified in advance. Common ways are to highlight frames, stringers and longitudinal structural members of the aircraft to track deformation. Other times, discrete targets are placed at structural junctions, ATD limbs or other areas of interest to gather specific results at those locations. Figure 2 shows one example on a GA test conducted in 1977 where the test article was painted a light yellow, over which the stiffeners, frame sections and rivet line locations were painted with black lines. There are yellow and black (commonly called “bowtie”) stickers applied at the CG on the door and near the bottom of the firewall locations. No other types of tracking targets are visible.

Figure 2 also shows a white grid background, along with a grid pattern painted into the impact surface. The grid pattern in the background is located on a movable backboard (still in use) that can be placed behind the impact location specified by the test conditions. Both of these items were used to provide a reference

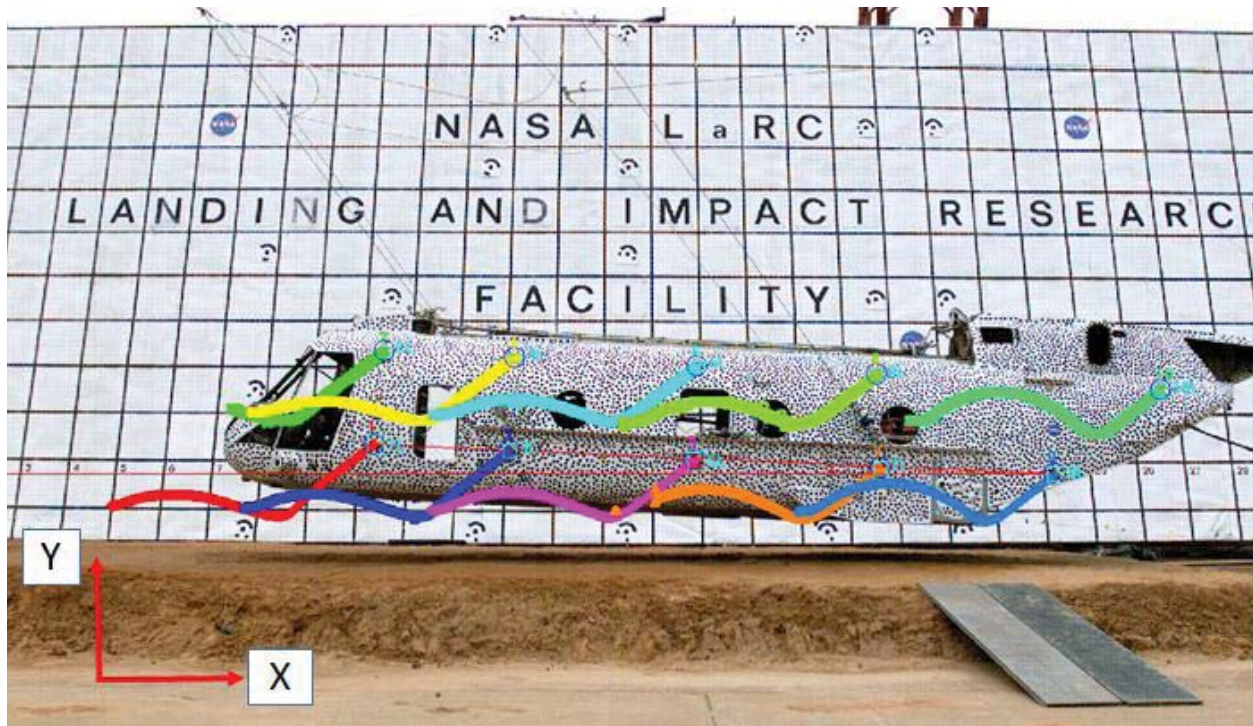
Figure 4 – TRACT 1 target tracking marker time history

Target locations were measured prior to the test and these measurements established both a baseline target location, and also scaling factors needed in data processing. A coordinate system was established using the grid on the backboard, located behind the test article and visible in Figure 4. Figure 4 shows the created points, tracked through the time history during the crash, starting with the first tracked position, slightly before impact.

The tracking algorithms used on the markers in Figure 4 started at the end of the swing, approximately 0.070 sec. prior to impact. During the final stages of the swing, the vehicle exhibited motion downward (negative Y direction) and leftward (negative X direction), which is the motion of the swing dynamics due to the pendulum swing. The markers reached a minimum, which represented the impact position, then exhibited upward and leftward motion, which represented the rebound. The distance between the minimum at impact and the relative max during the post impact arc was the maximum rebound position and grew larger when examining the data starting at the front of the airframe going to the rear. The vehicle came to rest shortly thereafter, and the location at rest is shown in Figure 4 at the final left-most point. Figure 5 shows the time history of the marker velocities, which is computed by taking the time differential of the marker positions.

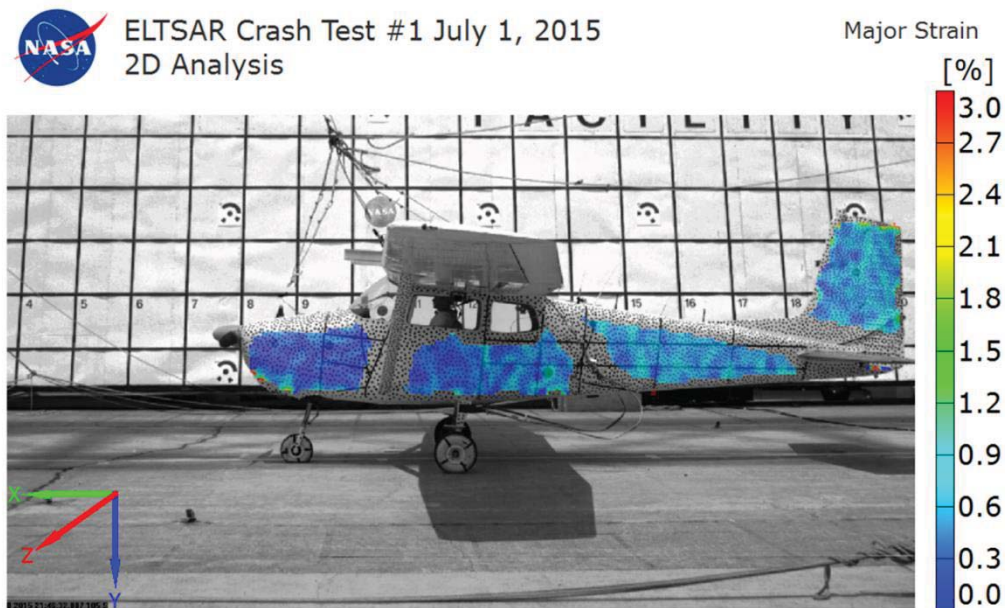
The target-tracking analysis gave insight into the response of the airplane during the impact event. However, the digital image correlation results will next be examined to investigate airframe response further. After removing all perceived spurious data, there were only small portions of the airframe which gave data usable for analysis, shown in Figure 29. The four major areas where data were resolved on the

airplane were the engine compartment, the cabin, the mid-to-rear tail and the vertical stabilizer. The dot spacing used on the airplane gave a data point every 1.75 in. along the skin of the airplane.

Figure 29 - Data set resolved for use in ELTSAR Test 1 analysis

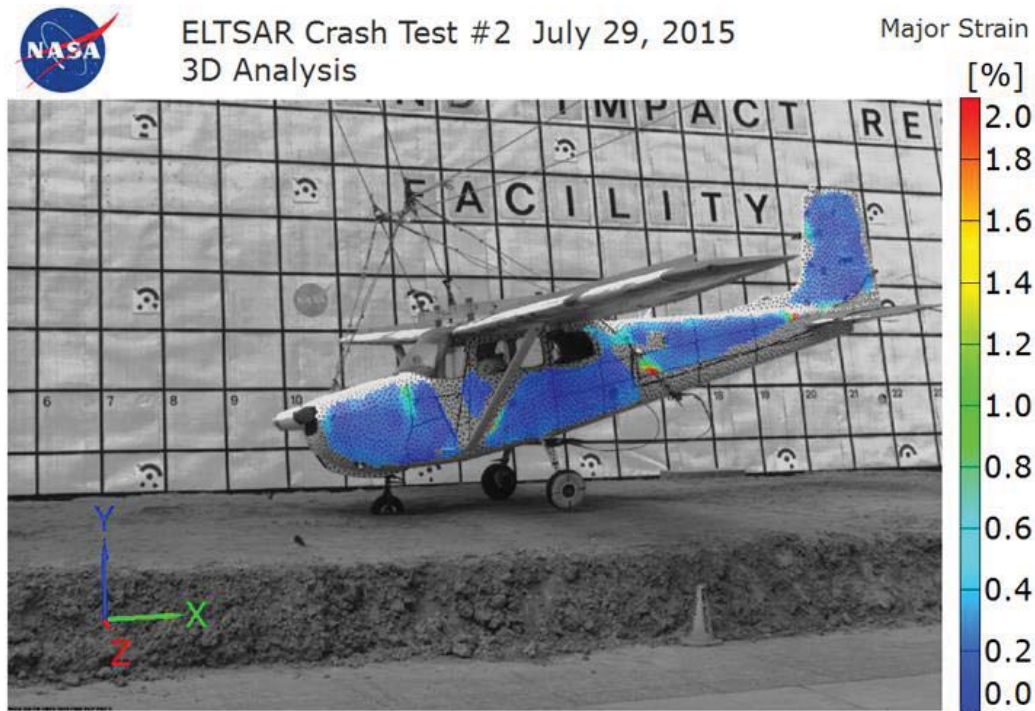
There was a substantial amount of damage on the airframe due to plowing and rotation. The strain on the skin was next examined in an attempt to quantify the deformation. Figure 38 presents major strain on the airframe approximately 0.021 sec. after initial nose gear to soil contact.

Figure 38 - ELTSAR Test 2 major strain at $t+0.021$ sec

Figure 38 also shows the erroneous data on the tail at the location of the DAS umbilical, which was also seen in ELTSAR Test 1. After ignoring these data, the major result is shown on the nose at the firewall location. The nose wheel has started to penetrate the soil, which creates a pivot point for the start of rotation. The strain developed at this location is the beginning of the deformation of the nose of the aircraft due to the rotation about the nose wheel, while the majority of the rest of the airframe is unaffected at this time. Figure 39 shows the major strain developed a short time later, at 0.063 sec. after impact, or 0.042 sec. after the data shown in Figure 38.

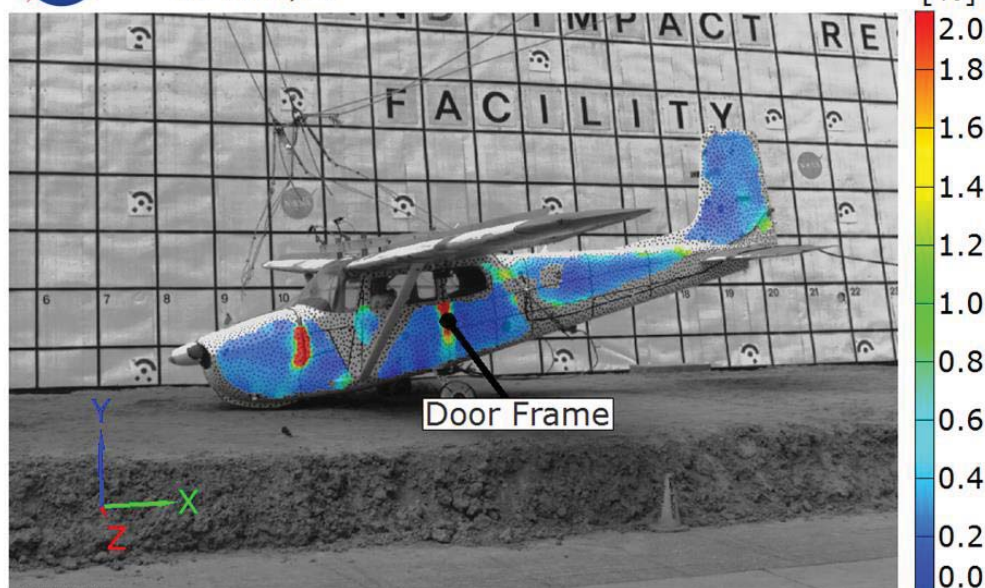
Figure 39 - ELTSAR Test 2 major strain at $t+0.063$ sec

Figure 39 shows that the nose wheel has now penetrated fully into the soil, developing very large major strain at the firewall location on the nose. It also shows large amounts of major strain developing at the door opening location in the cabin of the airplane. This location is where the door latches into the body of the airframe, and, as shown in Test 1, represents a discontinuity in the airframe skin. It is easy to see why the strain would develop here as the relative motion between the door frame and airframe body would show up as a perceived strain in the data, which is really a weak spot in the airframe. A point in this high area of strain at the door frame location was picked for further interrogation, and the time history is shown in Figure 40.
